Report on Conservation Works required to
Cloonsellan Abbey, Ballymurray, Co Roscommon

November 2018

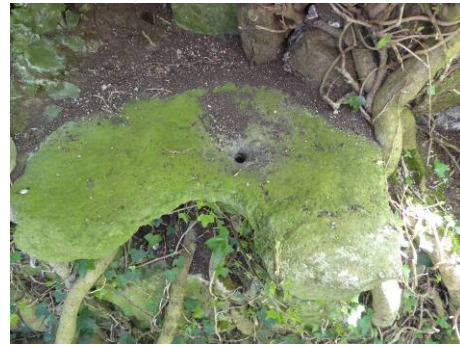
Fig 04: Possible piscina

There is a small but hugely significant section of the original wall remaining at the south east corner. This is where the niche containing the possible piscina is located. Ivy roots are completely tangled with the niche stonework, endangering this feature.

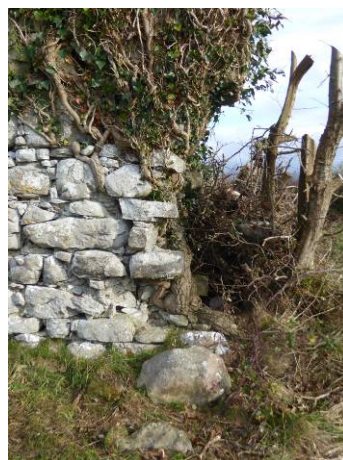
Fig 07: Trees growing from base of wall, high level stone not supported

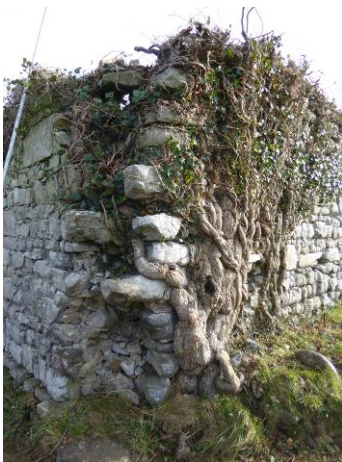
The walls extend to approx. 3.5, at the highest points measured externally and the internal ground level is approximately 300mm lower than outside. All the corners have been severely damaged potentially by livestock rubbing against these sharp corners, a common feature of medieval masonry in farmland. This loss of stone removes the tie between the joining walls and severely reduces the structural stability of both walls. There are also two small trees growing out of the base of the wall at the south west corner. The facing stone on the external elevations is generally still in position but there are large pockets lost on the internal faces. Unfortunately the facing stone will continue to unravel at an ever increasing rate now that the core stonework is exposed to the weather. The bedding mortar has largely been washed out of the joints throughout, also leaving the facing stone vulnerable to serious collapse. The wall tops are completely overgrown and large ivy roots can be seen penetrating into the core stonework. A relatively minor collapse recently took place during a storm. Stonework was lost from the west gable wall top and this collapsed stone now lies as it fell at the base of the wall. This is an unfortunate loss of historic fabric and demonstrates the vulnerability of this medieval structure.

Fig 08: Connection between north and west elevation compromised

A number of areas have been identified where some stone reinstatement will be required to stabilise the structure. The main areas are at the four corners which have been severely undermined by the loss of facing stone and the core stonework behind. The most substantial area of reinstatement will be to the north west corner where the connection between the two walls has been almost completely lost. Luckily the base stone is in position above ground so there is clear evidence of the original line of the wall. The facing stone at high level is toothed which will enable the re-built to be more successfully bonded to the original. The size of stone and coursing of the replacement will be determined by the existing facing stone on each side. The core stone is to be carefully rebuilt at the same time ensuring there are no voids.

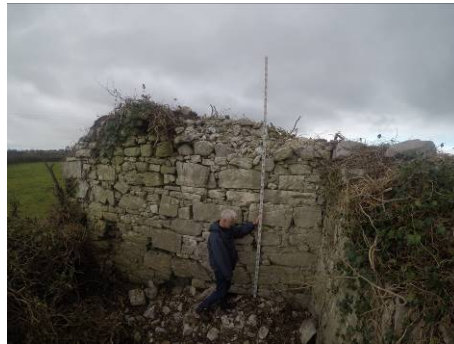
Fig 09: Recent loss of stone on west elevation and ivy roots on wall tops visible

The recently collapsed stone from the inside face of the west elevation can clearly be identified on the ground below the wall. It is intended to reinstate these stones to reform the inside face of the elevation. The original facing stones are identifiable by the weathering on the face and these will be set aside for reinstatement. The remaining collapsed stone will be used to consolidate the core behind.

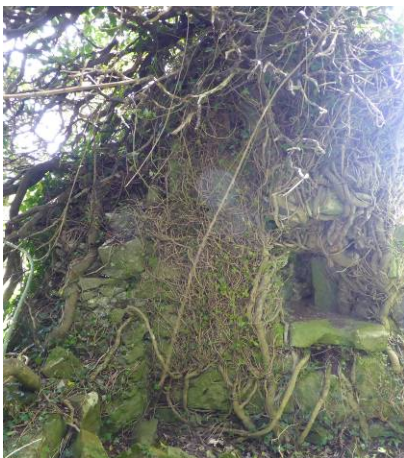
Fig 10: Niche entangle with ivy roots, base of east wall visible

The ivy roots are to be injected a number of weeks in advance of the works progressing to ensure they are dead by the time they are removed. It is essential that the ivy is only killed off when the funding is in place and a contractor appointed as killing ivy is detrimental to the stability of the structure if the conservation works did not proceed. During the works the vegetation will be removed incrementally from the structure ensuring the stonework is stabilised and conserved before moving on to the next section. All roots and organic material must be removed from the wall to prevent rapid regrowth of the vegetation.

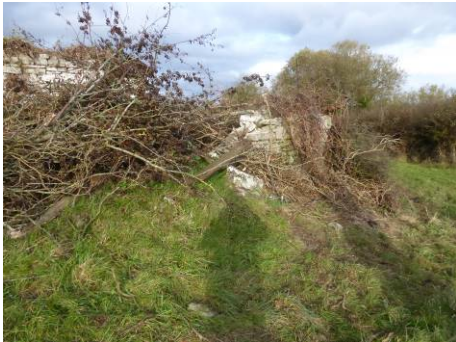
The ground level outside the structure on the south side is considerable higher than elsewhere. This would suggest that collapsed original stone is located below the growth. These high levels correspond closely to the areas that have suffered most fabric loss.

Fig 11: Mound on south side where collapsed stone is likely to be found

There is a large area of collapsed stone along the outside face of the south elevation. This is currently covered with soil and growth. It is intended to re-use this stone for the conservation and stabilisation of this structure. A significant amount of stone is required for some of the corners, particularly the north west, and it would be preferable to use stone from the original building rather than importing new stone to the site. The mound of stone will need to be carefully uncovered and inspected with the careful monitoring of the archaeologist. Stone suitable for re-use will need to be cleaned, sorted and stacked and the ground made good following the removal of the stone. All interventions will be carefully recorded by the design team.

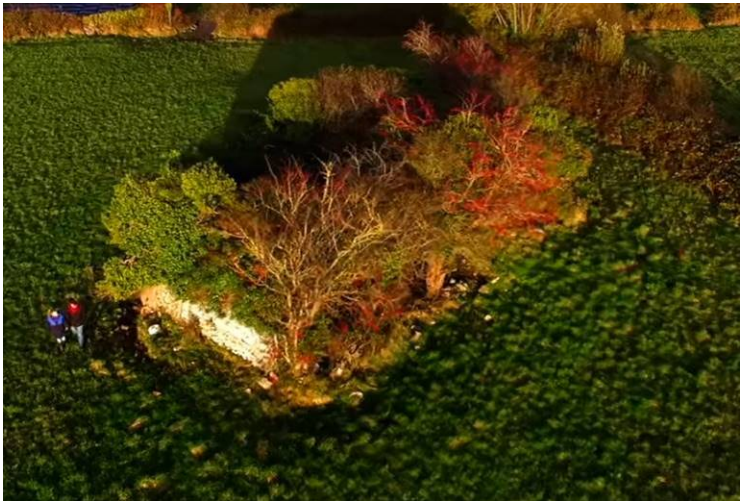
Aerial image of Abbey in 2017. Extent of vegetation cover visible

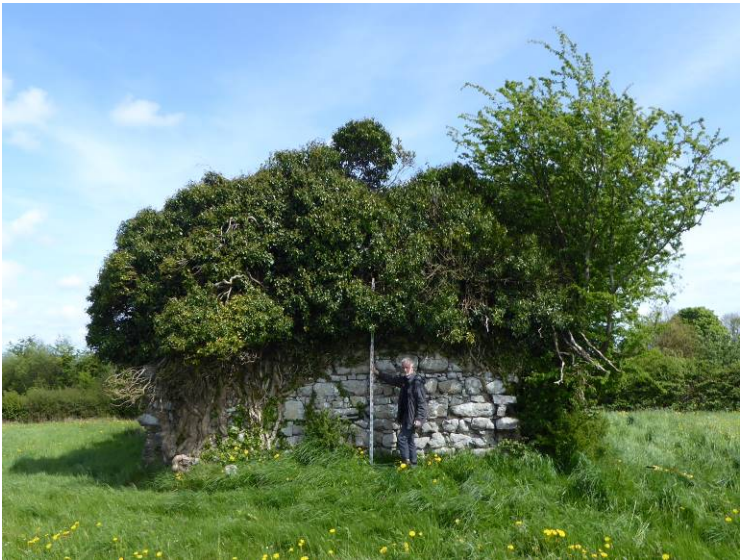
West elevation prior to vegetation trimming

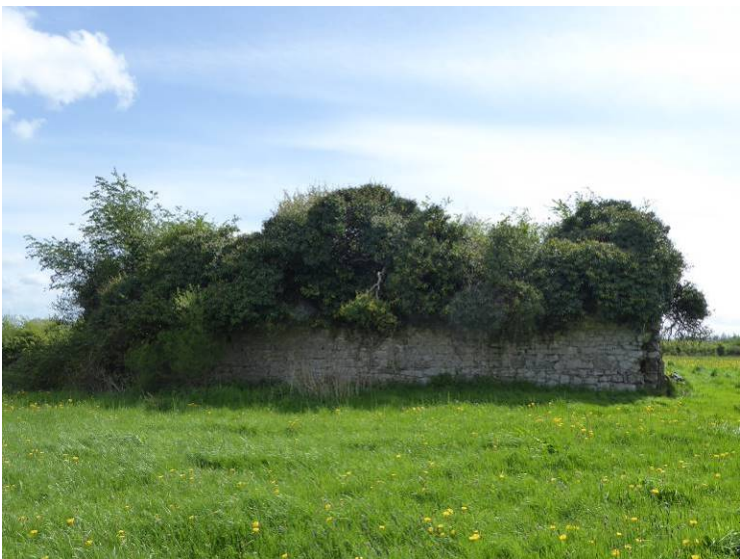
North elevation prior to vegetation trimming

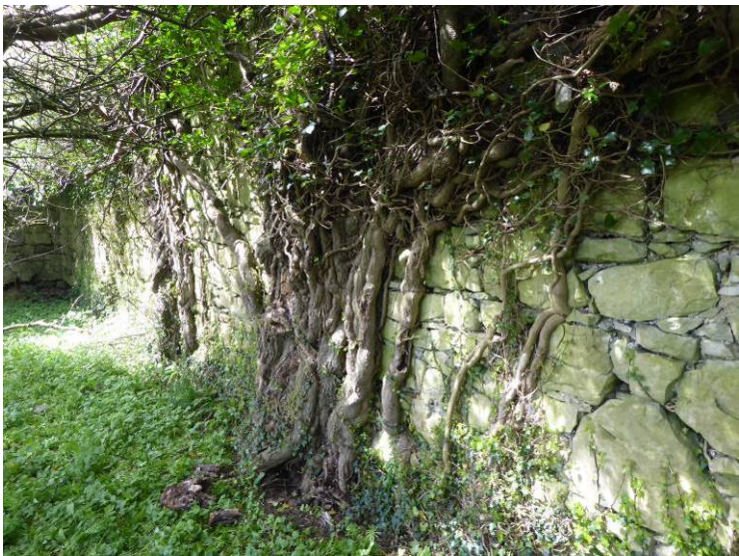
Inside face of north elevation prior to vegetation trimming

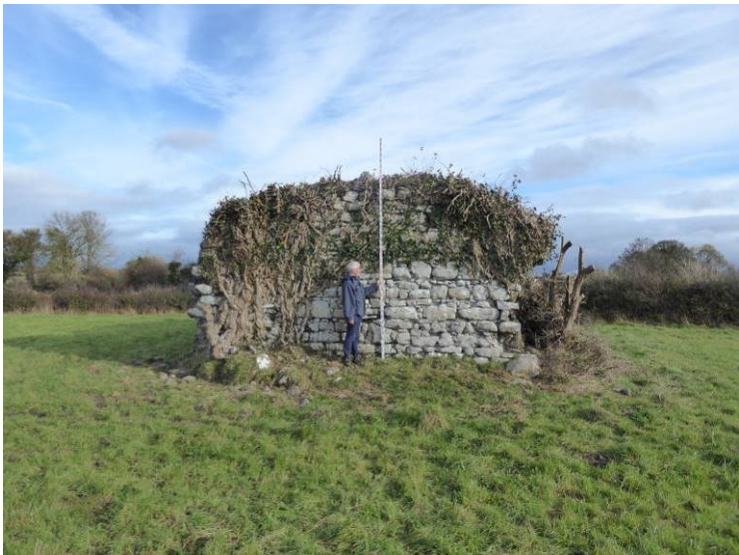
West elevation – stone lost at each corner and along wall top. No evidence of original building height

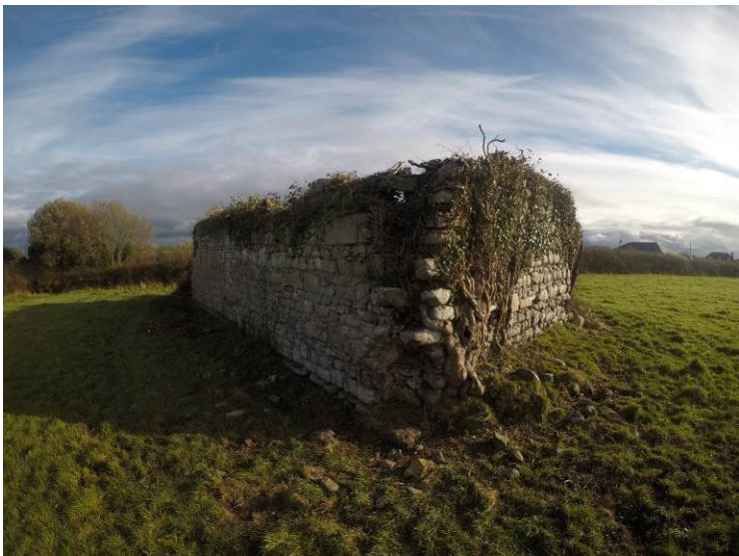
North west corner – Loss of corner stone clearly visible. Ivy roots visible along wall top of both walls

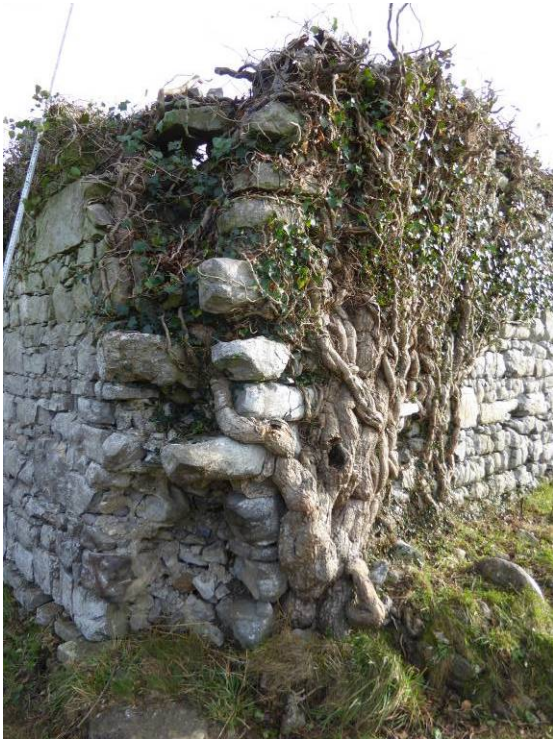
North west corner – Corner stone lost and ivy roots growing into core stonework

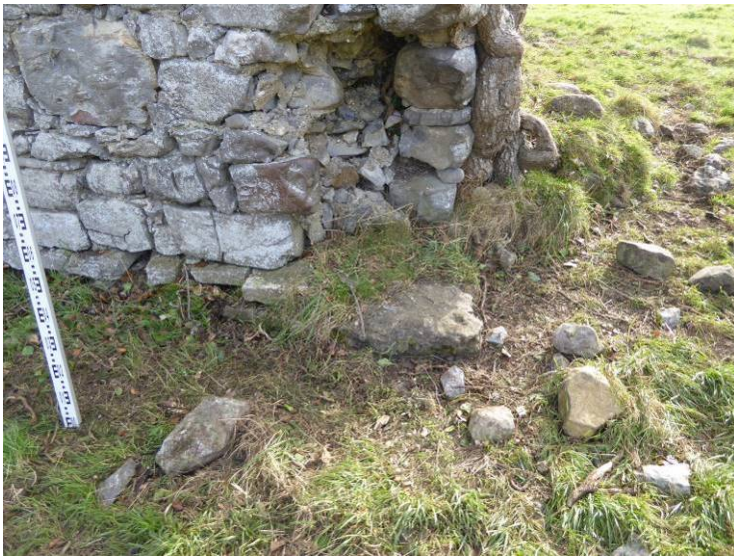
North west corner – Original base stone still in place

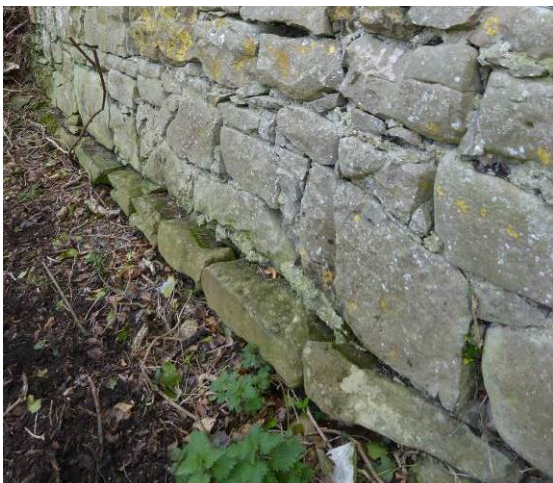
North elevation – Flat stone projecting at bottom of wall. This is likely to be the base of the wall

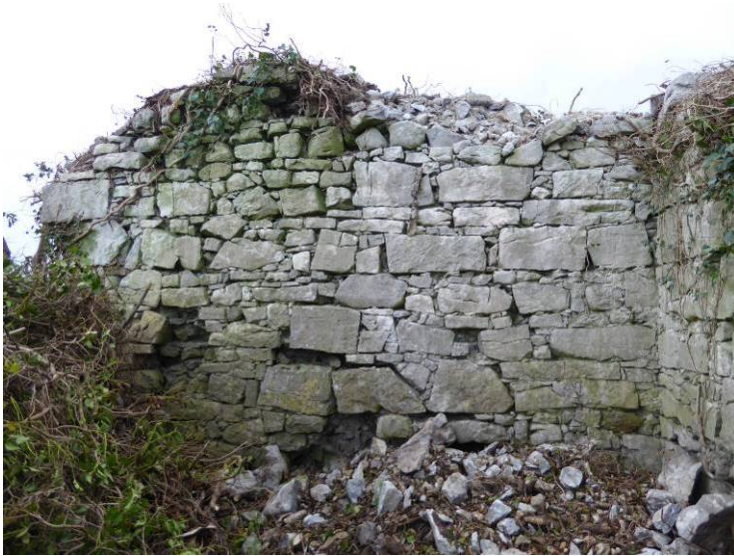
West elevation, internal face – Recent collapse evident on the wall top. Pockets of facing stone lost at low level

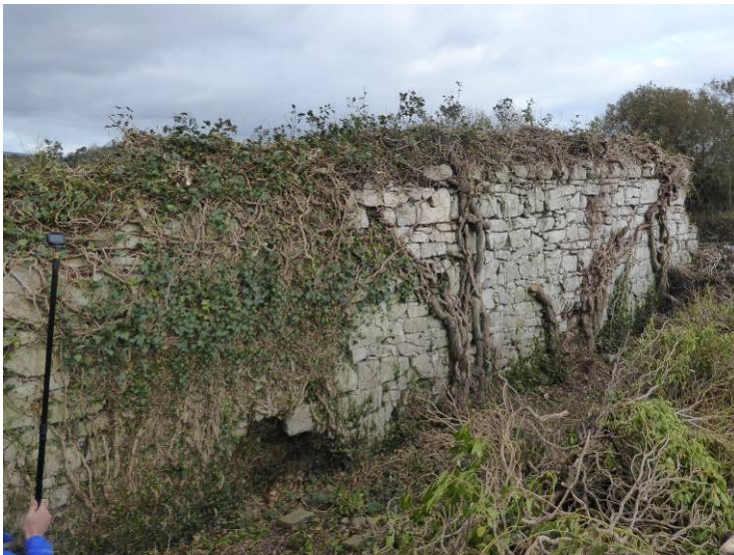
North elevation, internal face – Pockets of stone lost and extensive ivy coverage in areas.

There are a number of pockets of facing stone that have been lost, particularly on the internal faces. It is essential that these pockets are reinstated to support the stonework above and prevent further unravelling. The exposed stonework behind is to be stabilised where required and the bedding mortar pushed in behind the new facing stone to ensure there are no gaps in

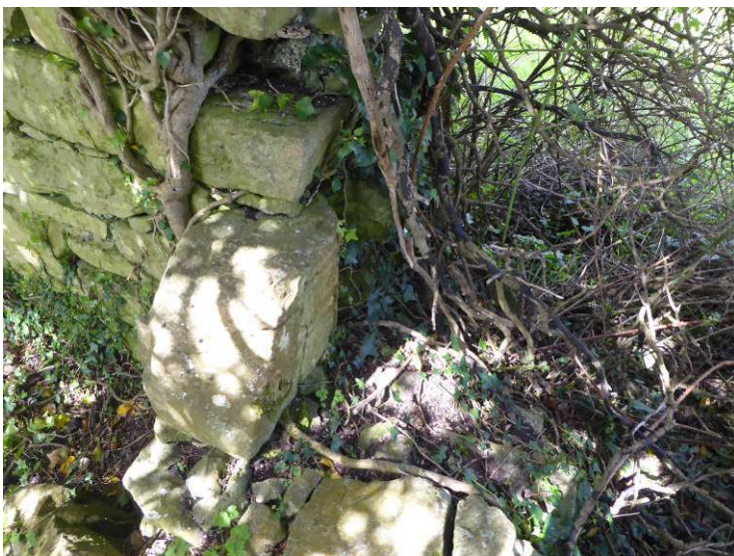
Original corner stone and base of wall still visible on east side

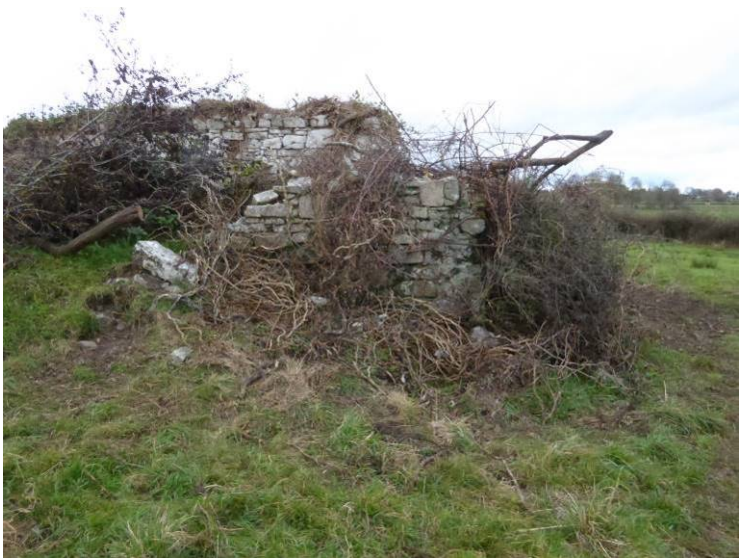
South wall – Low level original wall with potential collapsed stone at base under growth

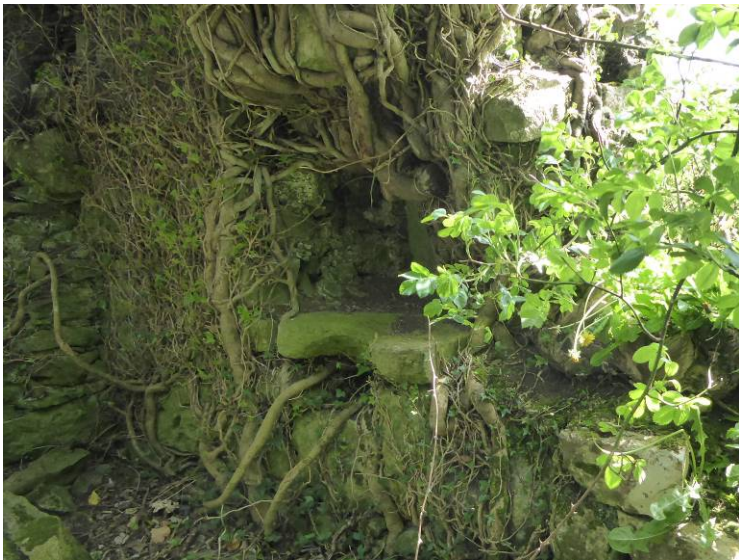
South wall, internal – Niche clearly visible with a stone base that may be a piscina

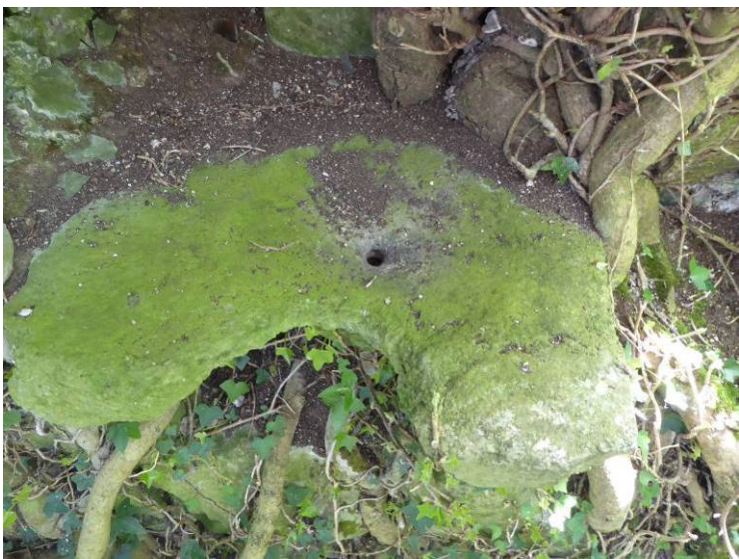
Image of potential piscina

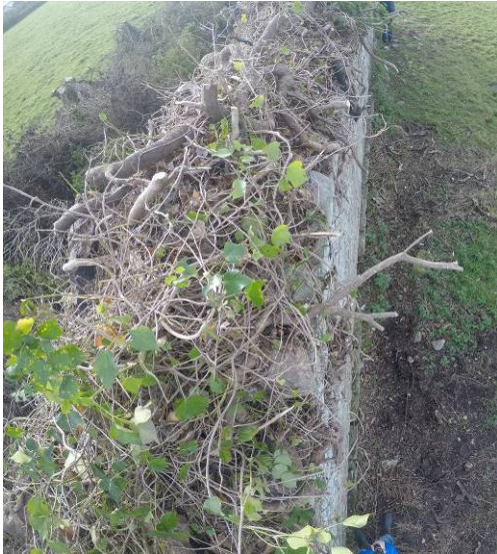
From the visual inspection it is clear that there is a large amount of organic material in the wall tops along with the ivy roots. This will all need to be carefully removed prior to any stabilisation taking place. From experience on other medieval structures in this area of the country it can be assumed that some dismantling of original stone along the wall top will be necessary to remove soil and roots. It is also likely that some of the existing stone has been dislodged from its original location by ivy roots. The wall tops will be closely inspected by the design team once the scaffolding has been erected.

Extent of ivy roots growing into core of wall along wall top clearly visible

Any facing stone requiring dismantling on the wall top will be numbered and recorded in position prior to dismantling and set aside for reinstatement. All roots and soil are to be carefully removed from the wall top before any consolidation can take place. On completion of the cleaning works any dismantled stone will be re-bedded in its original location. The core stonework may also need to be re-bedded in areas and some minor modifications to the core stone may be required to ensure water can run off from all areas of the wall top. On completion of stabilisation works the wall top is to be pointed, ensuring that joints are pinned wherever possible to reduce the width of these vulnerable horizontal joints. A fatty acid will be added to the pointing mix to reduce the amount of water that can penetrate to the core through the wall top.

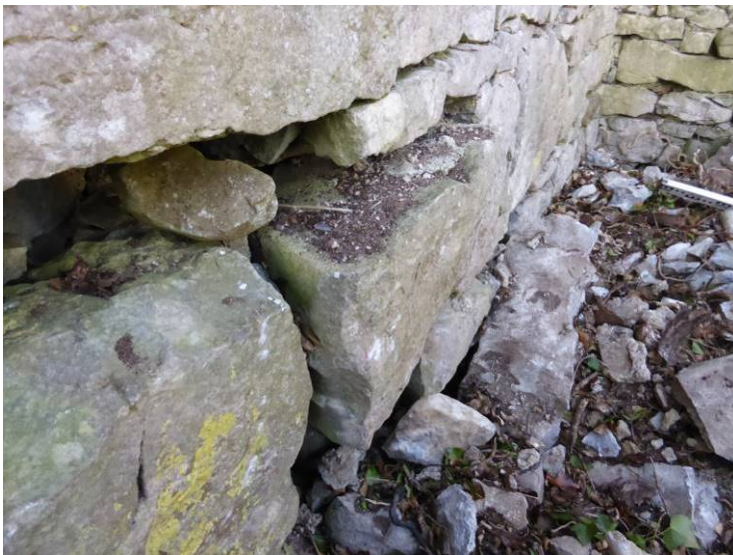
Large facing stone dislodged at low level

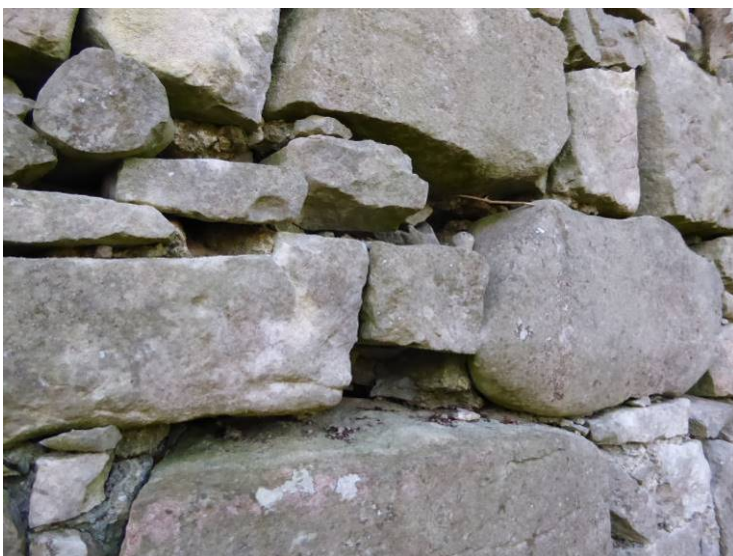
Much of the original bedding mortar has been washed out of the joints on all faces. This inevitably reduces the bond between facing stones and leaves them more susceptible to collapse. The building requires complete repointing with any small areas of sound bedding mortar retained.

Much of the bedding mortar has been washed out of the facing stone throughout

All joints are to be carefully raked out and organic material removed while retaining any sound bedding mortar. Three mortar samples from the core of the wall are to be analysed to identify the binder type, mix ratios and size of aggregate in the original mortar. This information will aid the design of a compatible repair mortar. Matching the original mix will not be practical in this case as the original aggregate is far too large to form part of a pointing mortar.
